Manhole Inspection Summary

Manhole # S13QQ1004MH

Insp Date: 11/1/06 9:09 AM

Location Address: **2600 OAKLEY AVE**

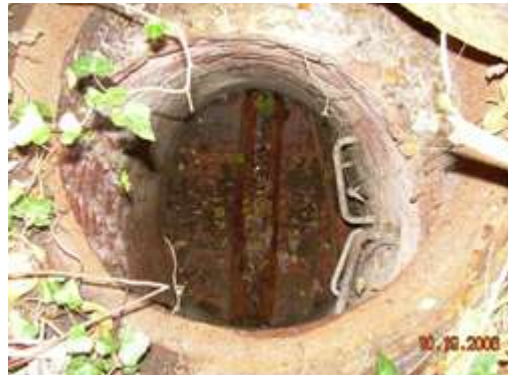
Top View

Bench debris. Channel debris.

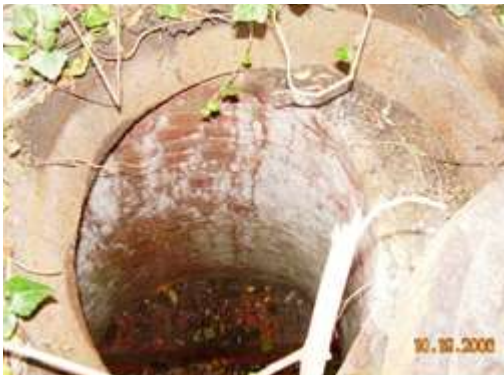
Defect

Frame Offset: **5** (in.) Condition: ☒ Sound ☐ Cracked ☐ Leaks

Infiltration: ☐ None ☒ **Joint** ☐ Cracks ☒ **Mortar** ☐ Roots ☐ Wall

Infiltration: ☐ None ☐ Joint ☐ Cracks ☒ **Mortar** ☐ Roots ☒ **Wall**

Frame offset. Adjustment and Barrel infiltration.

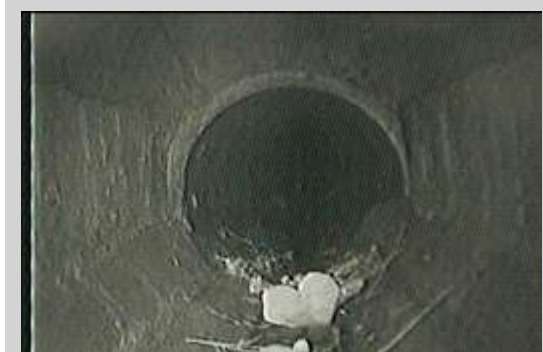
Pipe Out @ 12 O'Clock

Deposits: ☐ None ☐ Mud ☐ Sludge ☒ **Debris** ☐ **Grease**

Silt Depth: **0** (in.) Deposits Extent: **Light**

Infiltration: **Evidence** Pipe Seal Cond: **Unknown**

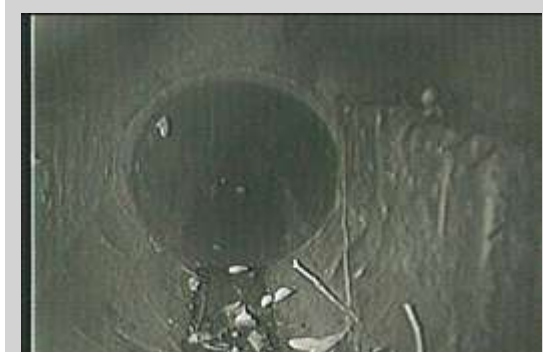
Pipe In @ 6 O'Clock

Deposits: ☐ None ☐ Mud ☐ Sludge ☐ Debris ☒ **Grease**

Silt Depth: **0** (in.) Deposits Extent: **Light**

Infiltration: **Evidence** Pipe Seal Cond: **Unknown**
